THE CITY OF  
SEGWIN

TITLE	
CONCRETE VALLEY GUTTER SHEET 1 OF 2	
SCALE:	DRAWING No.
N.T.S.	RDWY-7.1

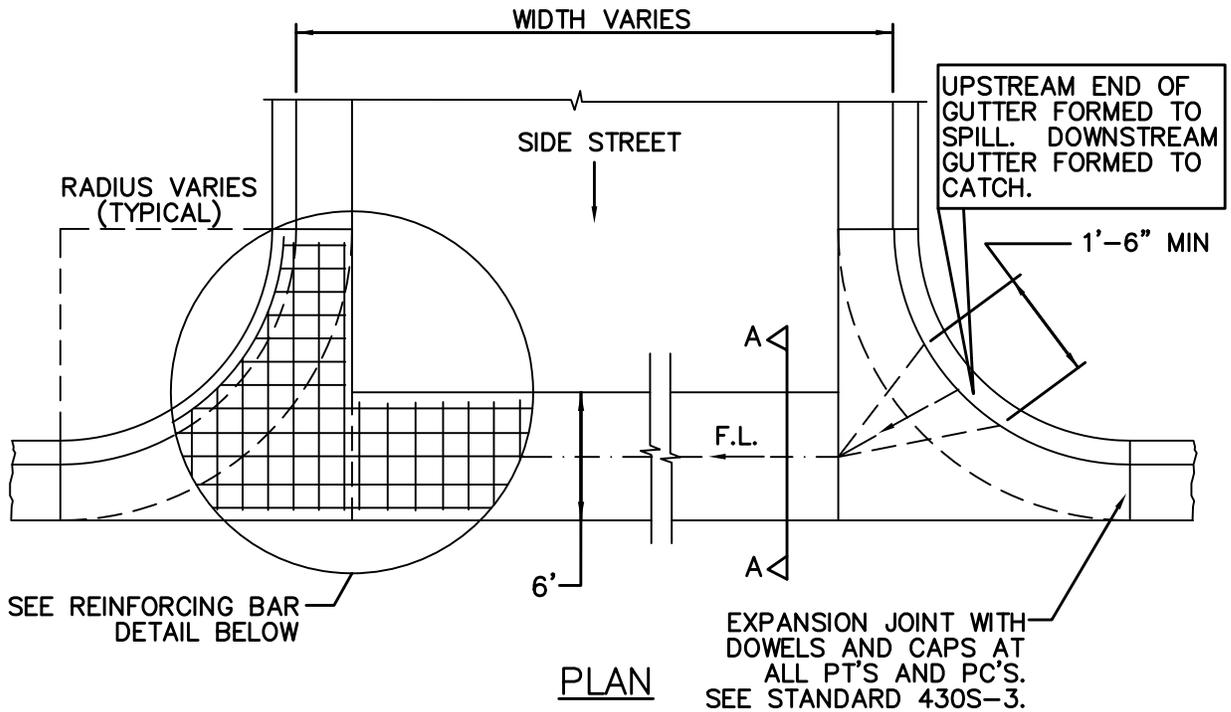
REINFORCING BAR DETAIL

ALTERNATE #4 BARS PLACED ON CHAIRS AT MIDDEPTH OF SLAB TO BE CONTINUOUS ACROSS EXPANSION JOINT. BREAK BOND 6" ON EACH SIDE OF EXPANSION JOINT.
